MBCA Meeting: 8pm –9pm February 10, 2026

# ASSESSMENT & FINDINGS

## OAK GROVE BEACH

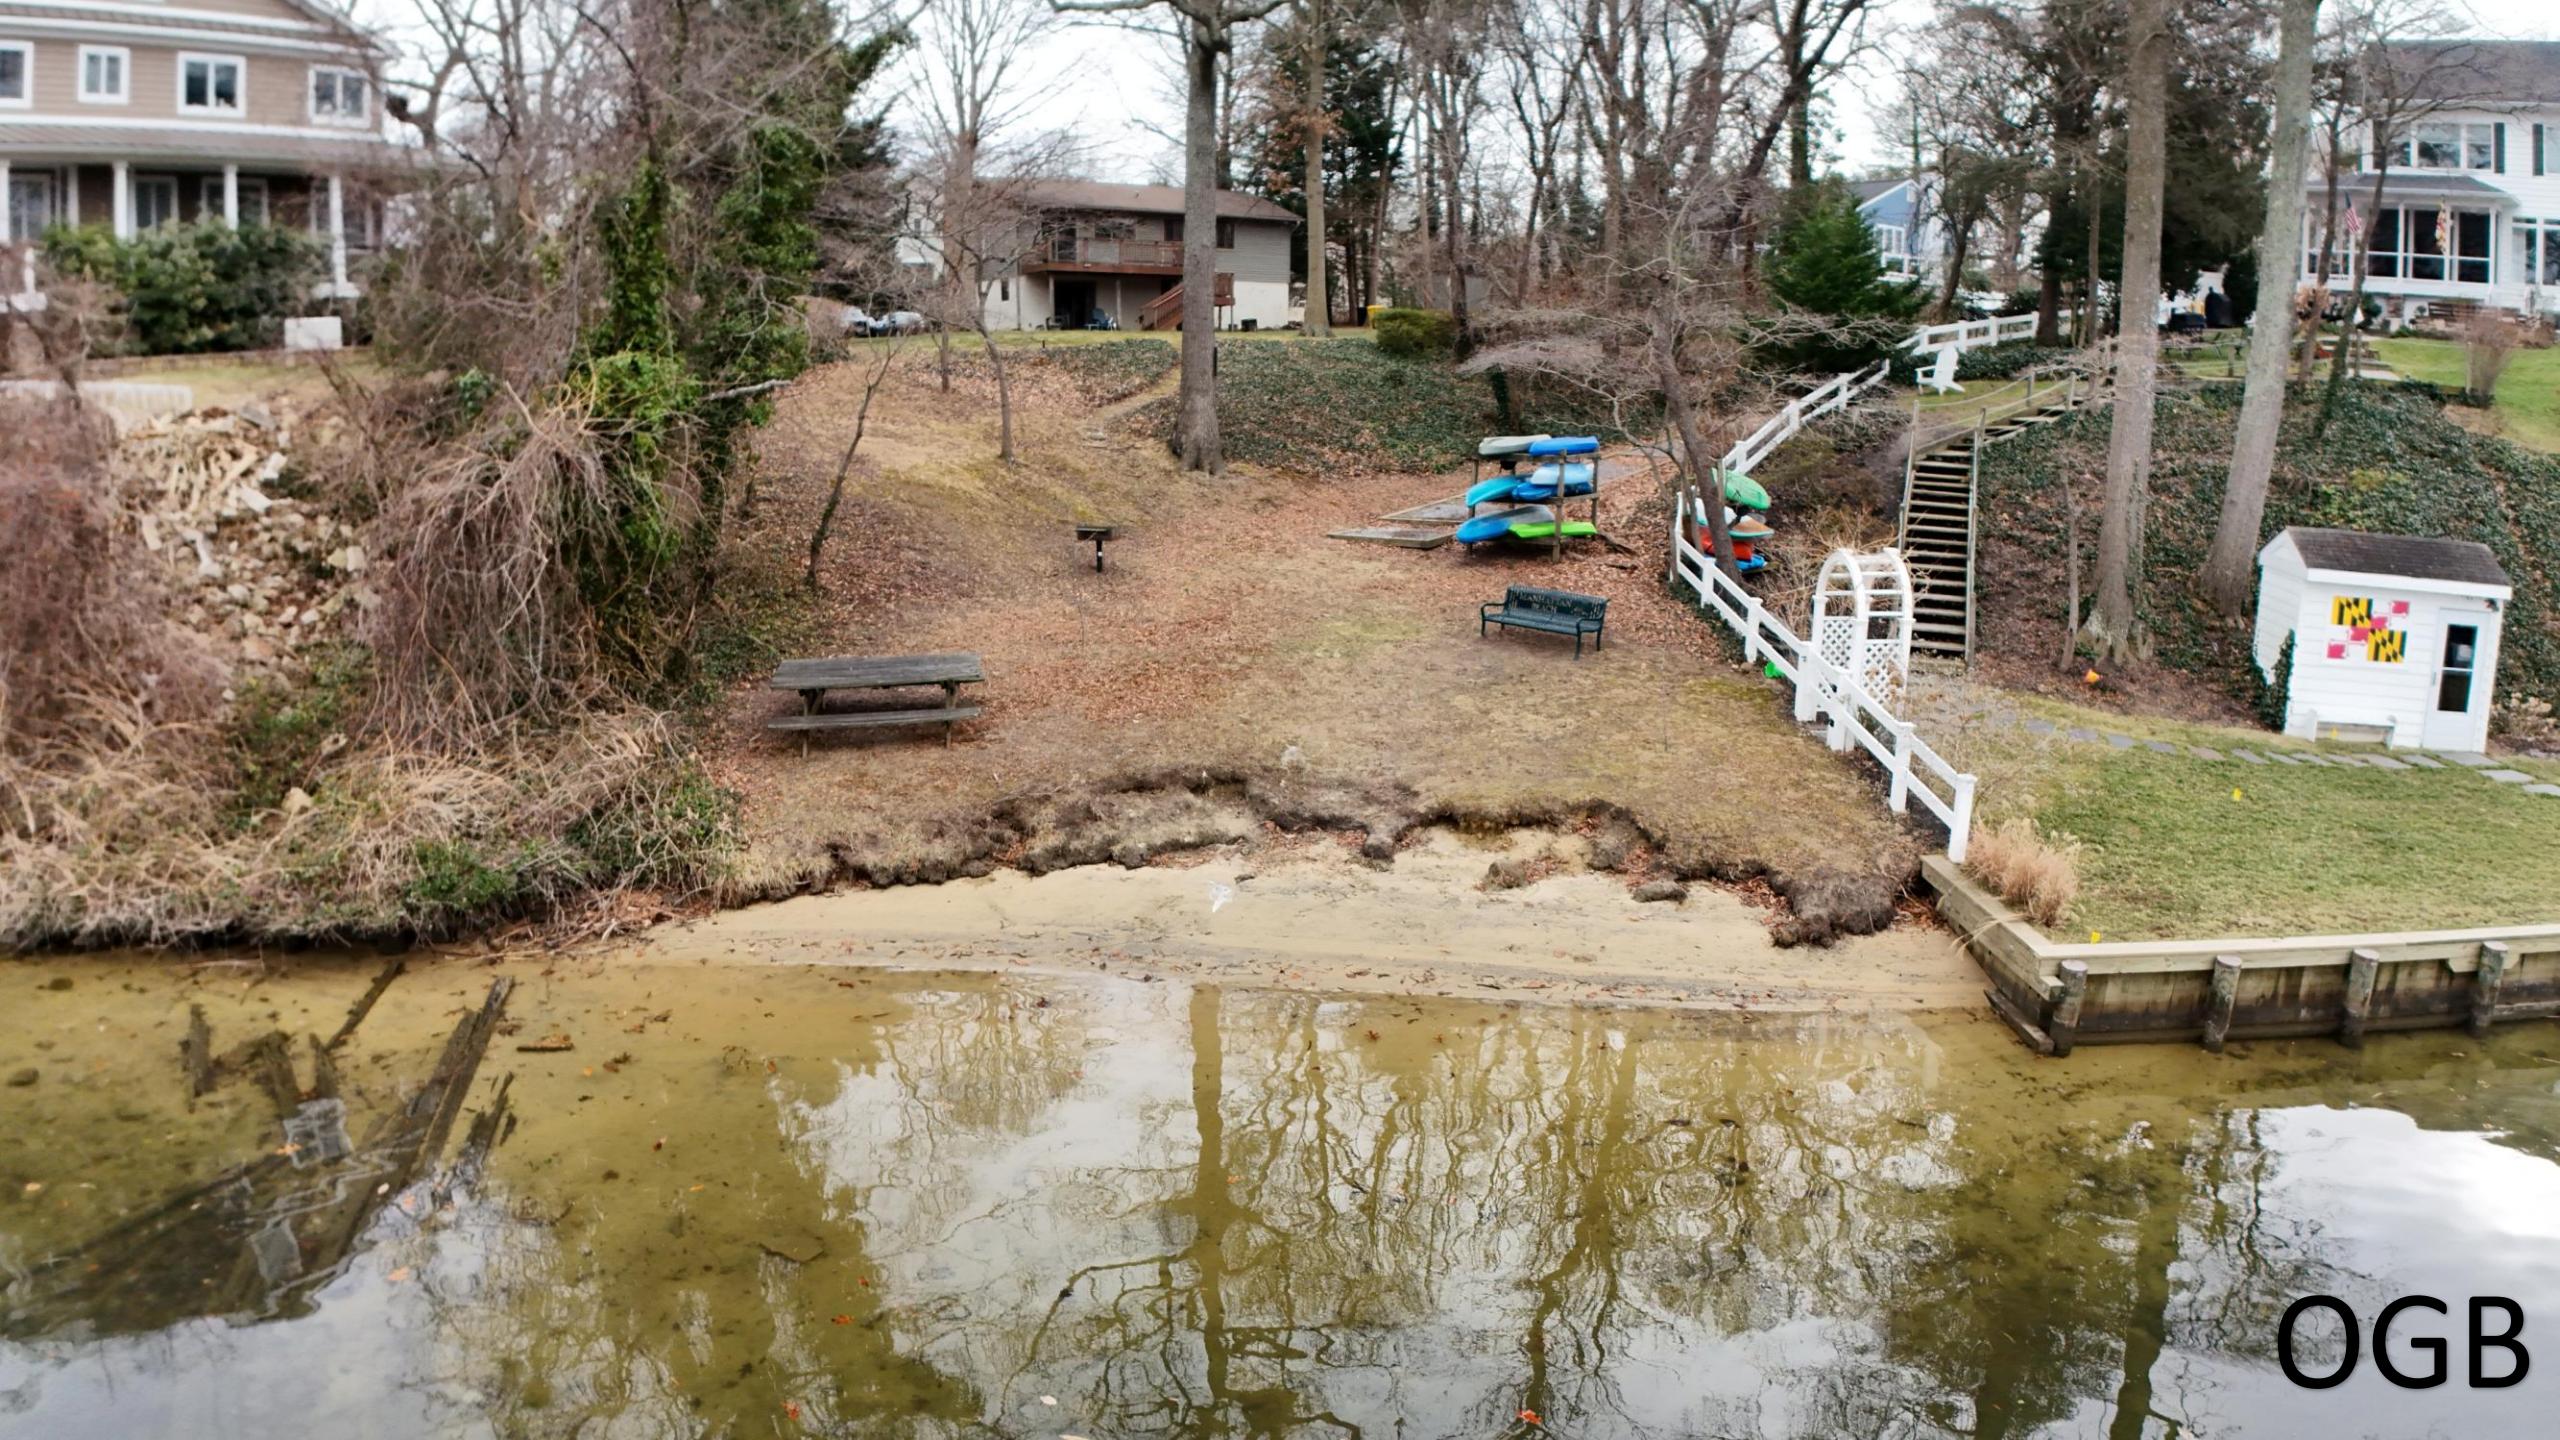
- OGB has experienced significant erosion at the water's edge over the past 8 years, and that erosion is accelerating.
- Sand has not been replenished in almost a decade.

- The waterfront has a significant drop off from the grass down to the sand. This is now a safety issue.
- The picnic table and grill are end of life and need to be removed or replaced. (Picnic table may be able to be restored/repaired)

- The steps to Oak Grove Circle are starting to shift in a few areas and could use some repair and additional backfill.
- The hill from the beach to the paper road is steep and challenging to walk up and down.

- When facing the water, the bottom right corner of the property line has significant vines and a large dying tree.
- On the right side of the beach, within the water, are the remnants of an old pier that are a safety issue for those playing in the water.

- There are several trees along the hill to the parking area that are leaning or dying and should be considered for removal.

- Grade the land roughly 5 feet above eroded area. Create a slope down to the sand.
- Fill sand from waterline to where the beach meets the newly graded land, roughly 18" deep.
- Repair or replace the existing picnic table.
- Remove the charcoal grill. It is end of life and in danger of falling over.
- Add another Kayak rack.
- Remove dying trees and ivy near water's edge (right side facing the water).
- Remove leaning trees along the right side of steps. (2)
- Move two trees recently planted at the beachfront to locations indicated on next slide.
- Remove old pier remnants in the water at the beach (right side in water)
- Aerate grass areas and overseed in the fall.

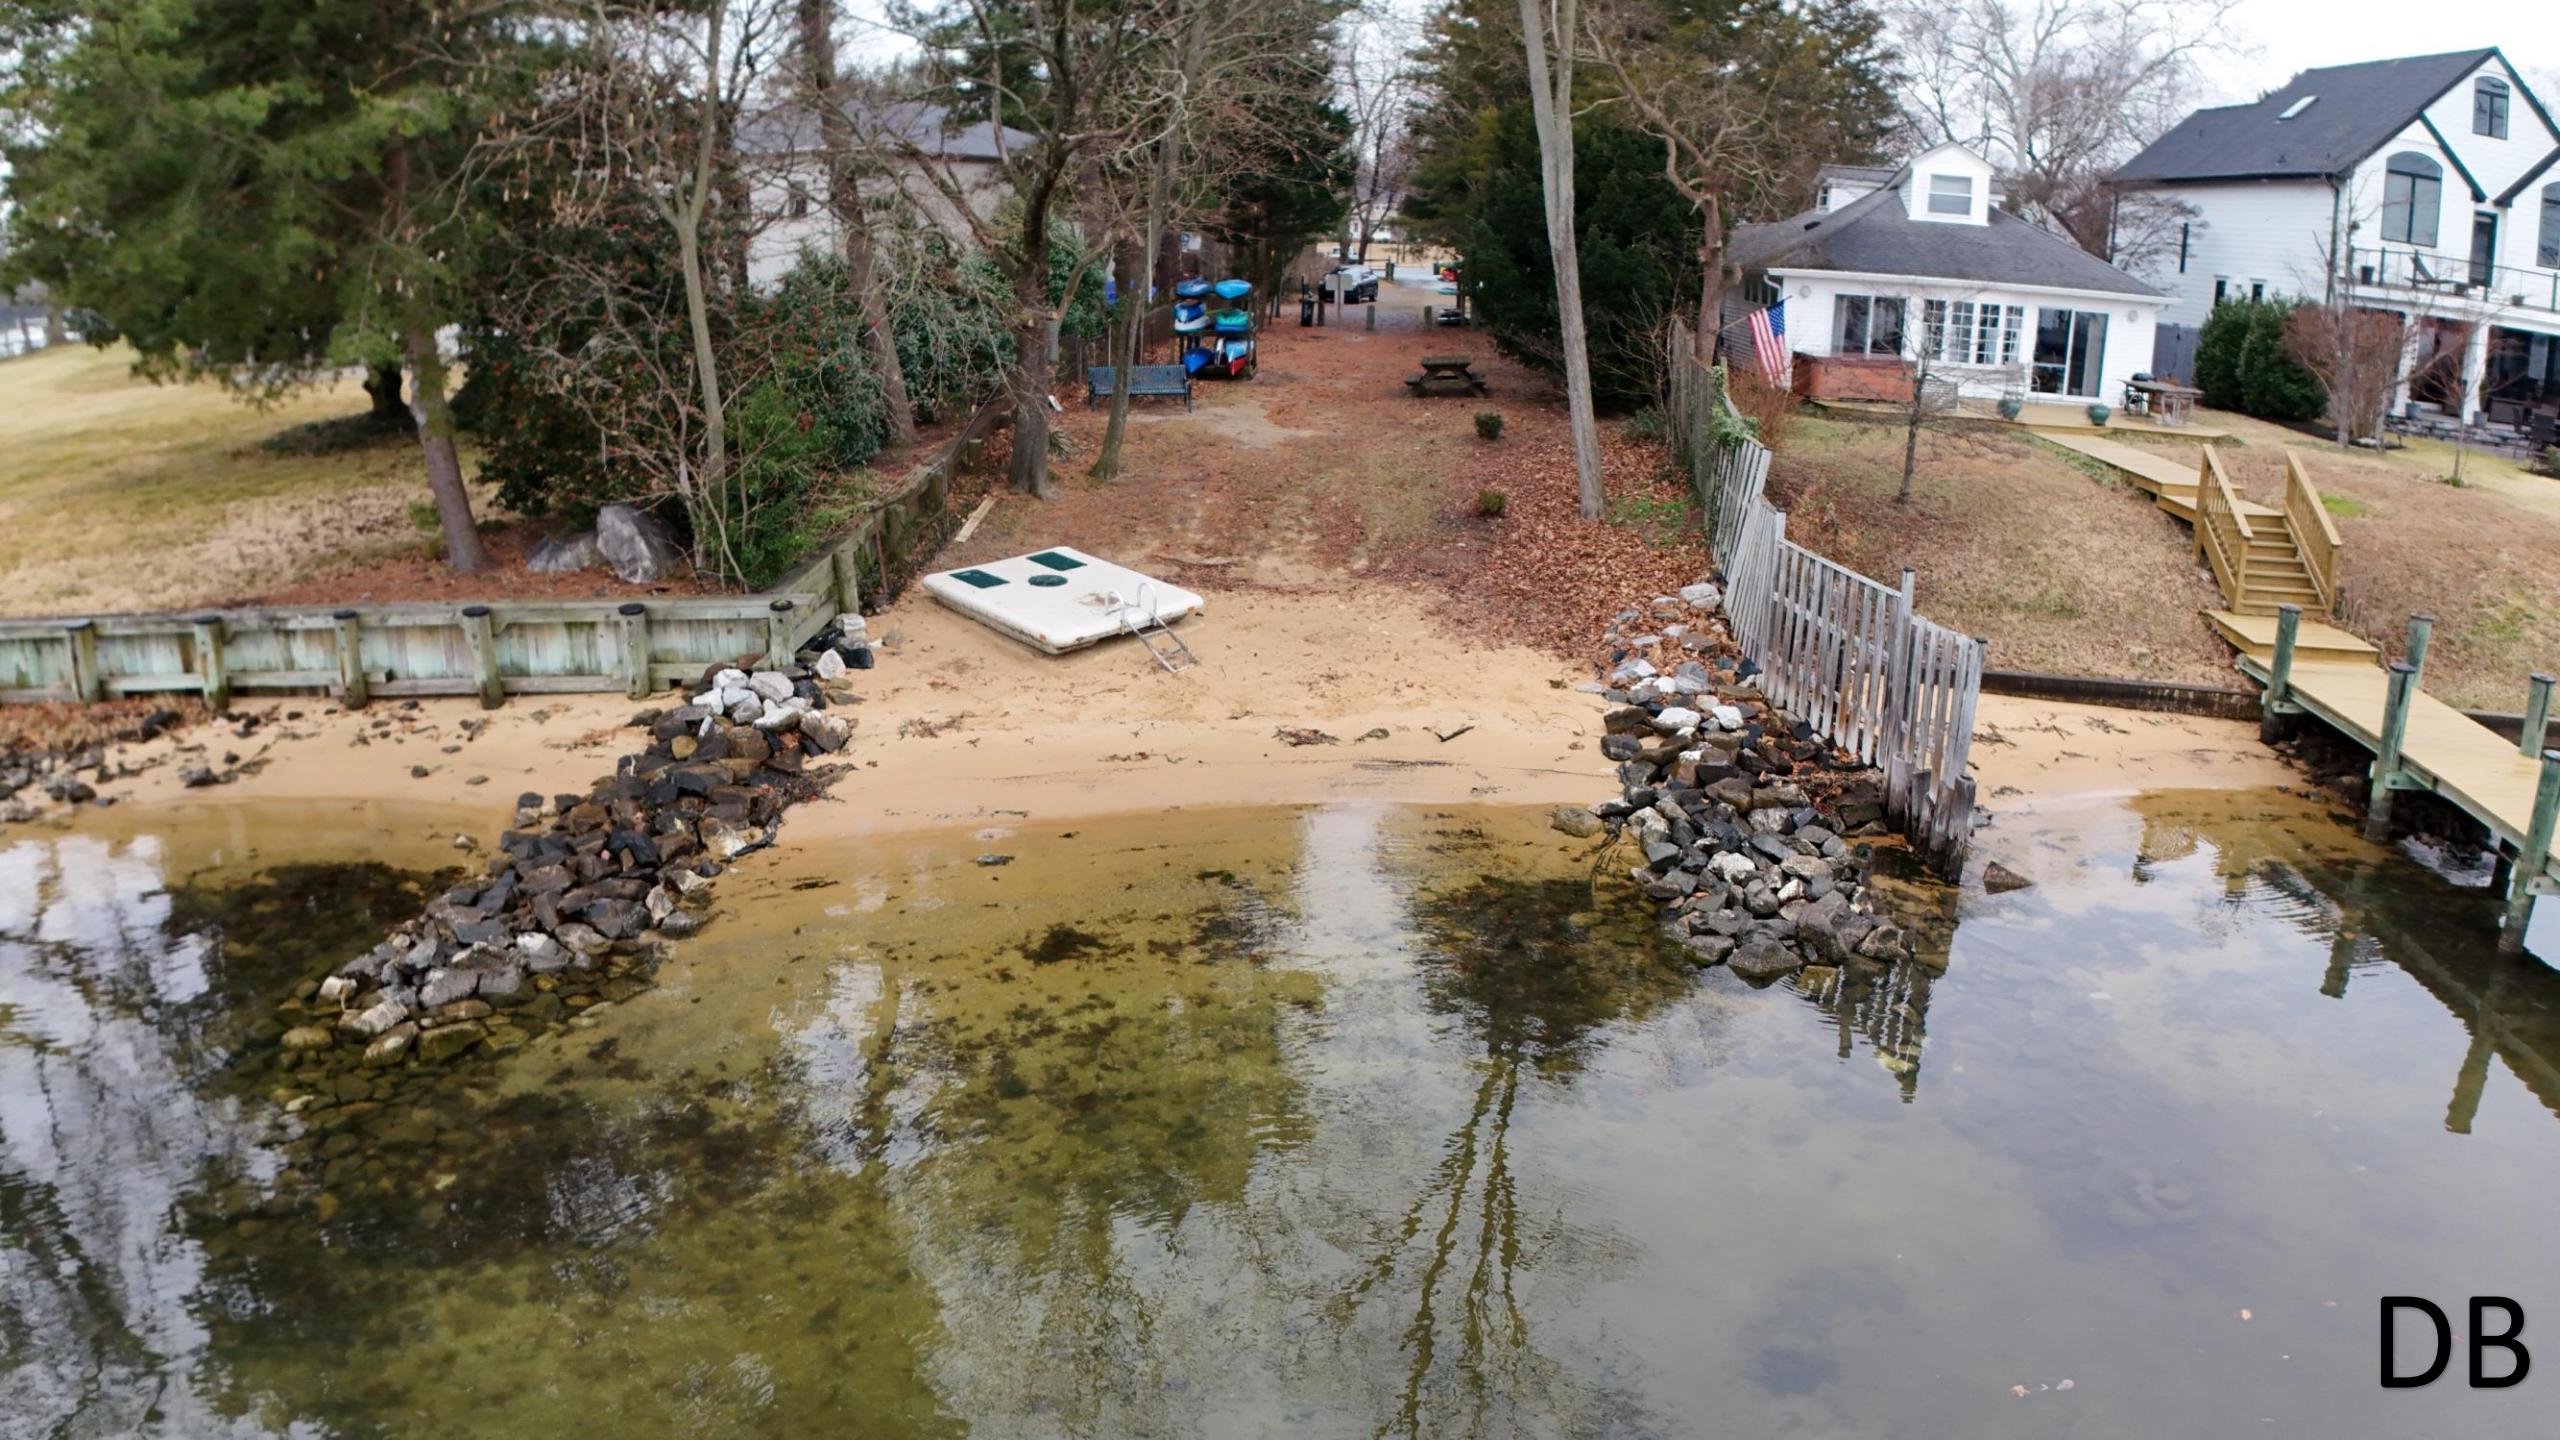
DB

- Dividing beach requires sand replenishment, and the steep hill leading to the beachfront is eroding as there is no longer grass growing due to a lack of sunlight. There are several dead or dying trees that should be removed.

- Pine needles from the excessive number of pine trees present on the property along with the lack of sunlight, have killed several shrubs and trees, and almost all grass.

- The significant number of trees and overgrown vegetation have further reduced the amount of space and sunlight near the front half of the property.
- The picnic table is end of life but may be able to be restored/repaired. The grill was recently removed as the post holding it failed.

- The fence on the left side (facing the water) is in need of repair near beach front. The metal fence on the right is an eyesore and there are 2 trees that have fused their trunks around it. Consult with neighbor about removing the metal fence.

- Regrade the land between the two large trees closest to the beach. (There is a steep hill created by high traffic down the center, dragging kayaks, etc.)
- Fill sand from waterline to where the beach meets the newly graded land, roughly 18" deep.
- Repair or replace the existing picnic table. Add another Kayak rack.
- Remove dying trees on right side nearest the beach.
- Remove several pine trees throughout the property. (TBD)
- Remove the large pine shrub on left side near the picnic table and replace with lower profile native vegetation.
- Trim all branches up to 1/3 the tree height, or 20 feet, whichever is less.
- Define landscaping area down length of both sides with a target of roughly 5 feet wide. Add thick layer of mulch.
- Install Bermuda grass from top of steps, up to the parking lot, in the center of property, between landscaping.

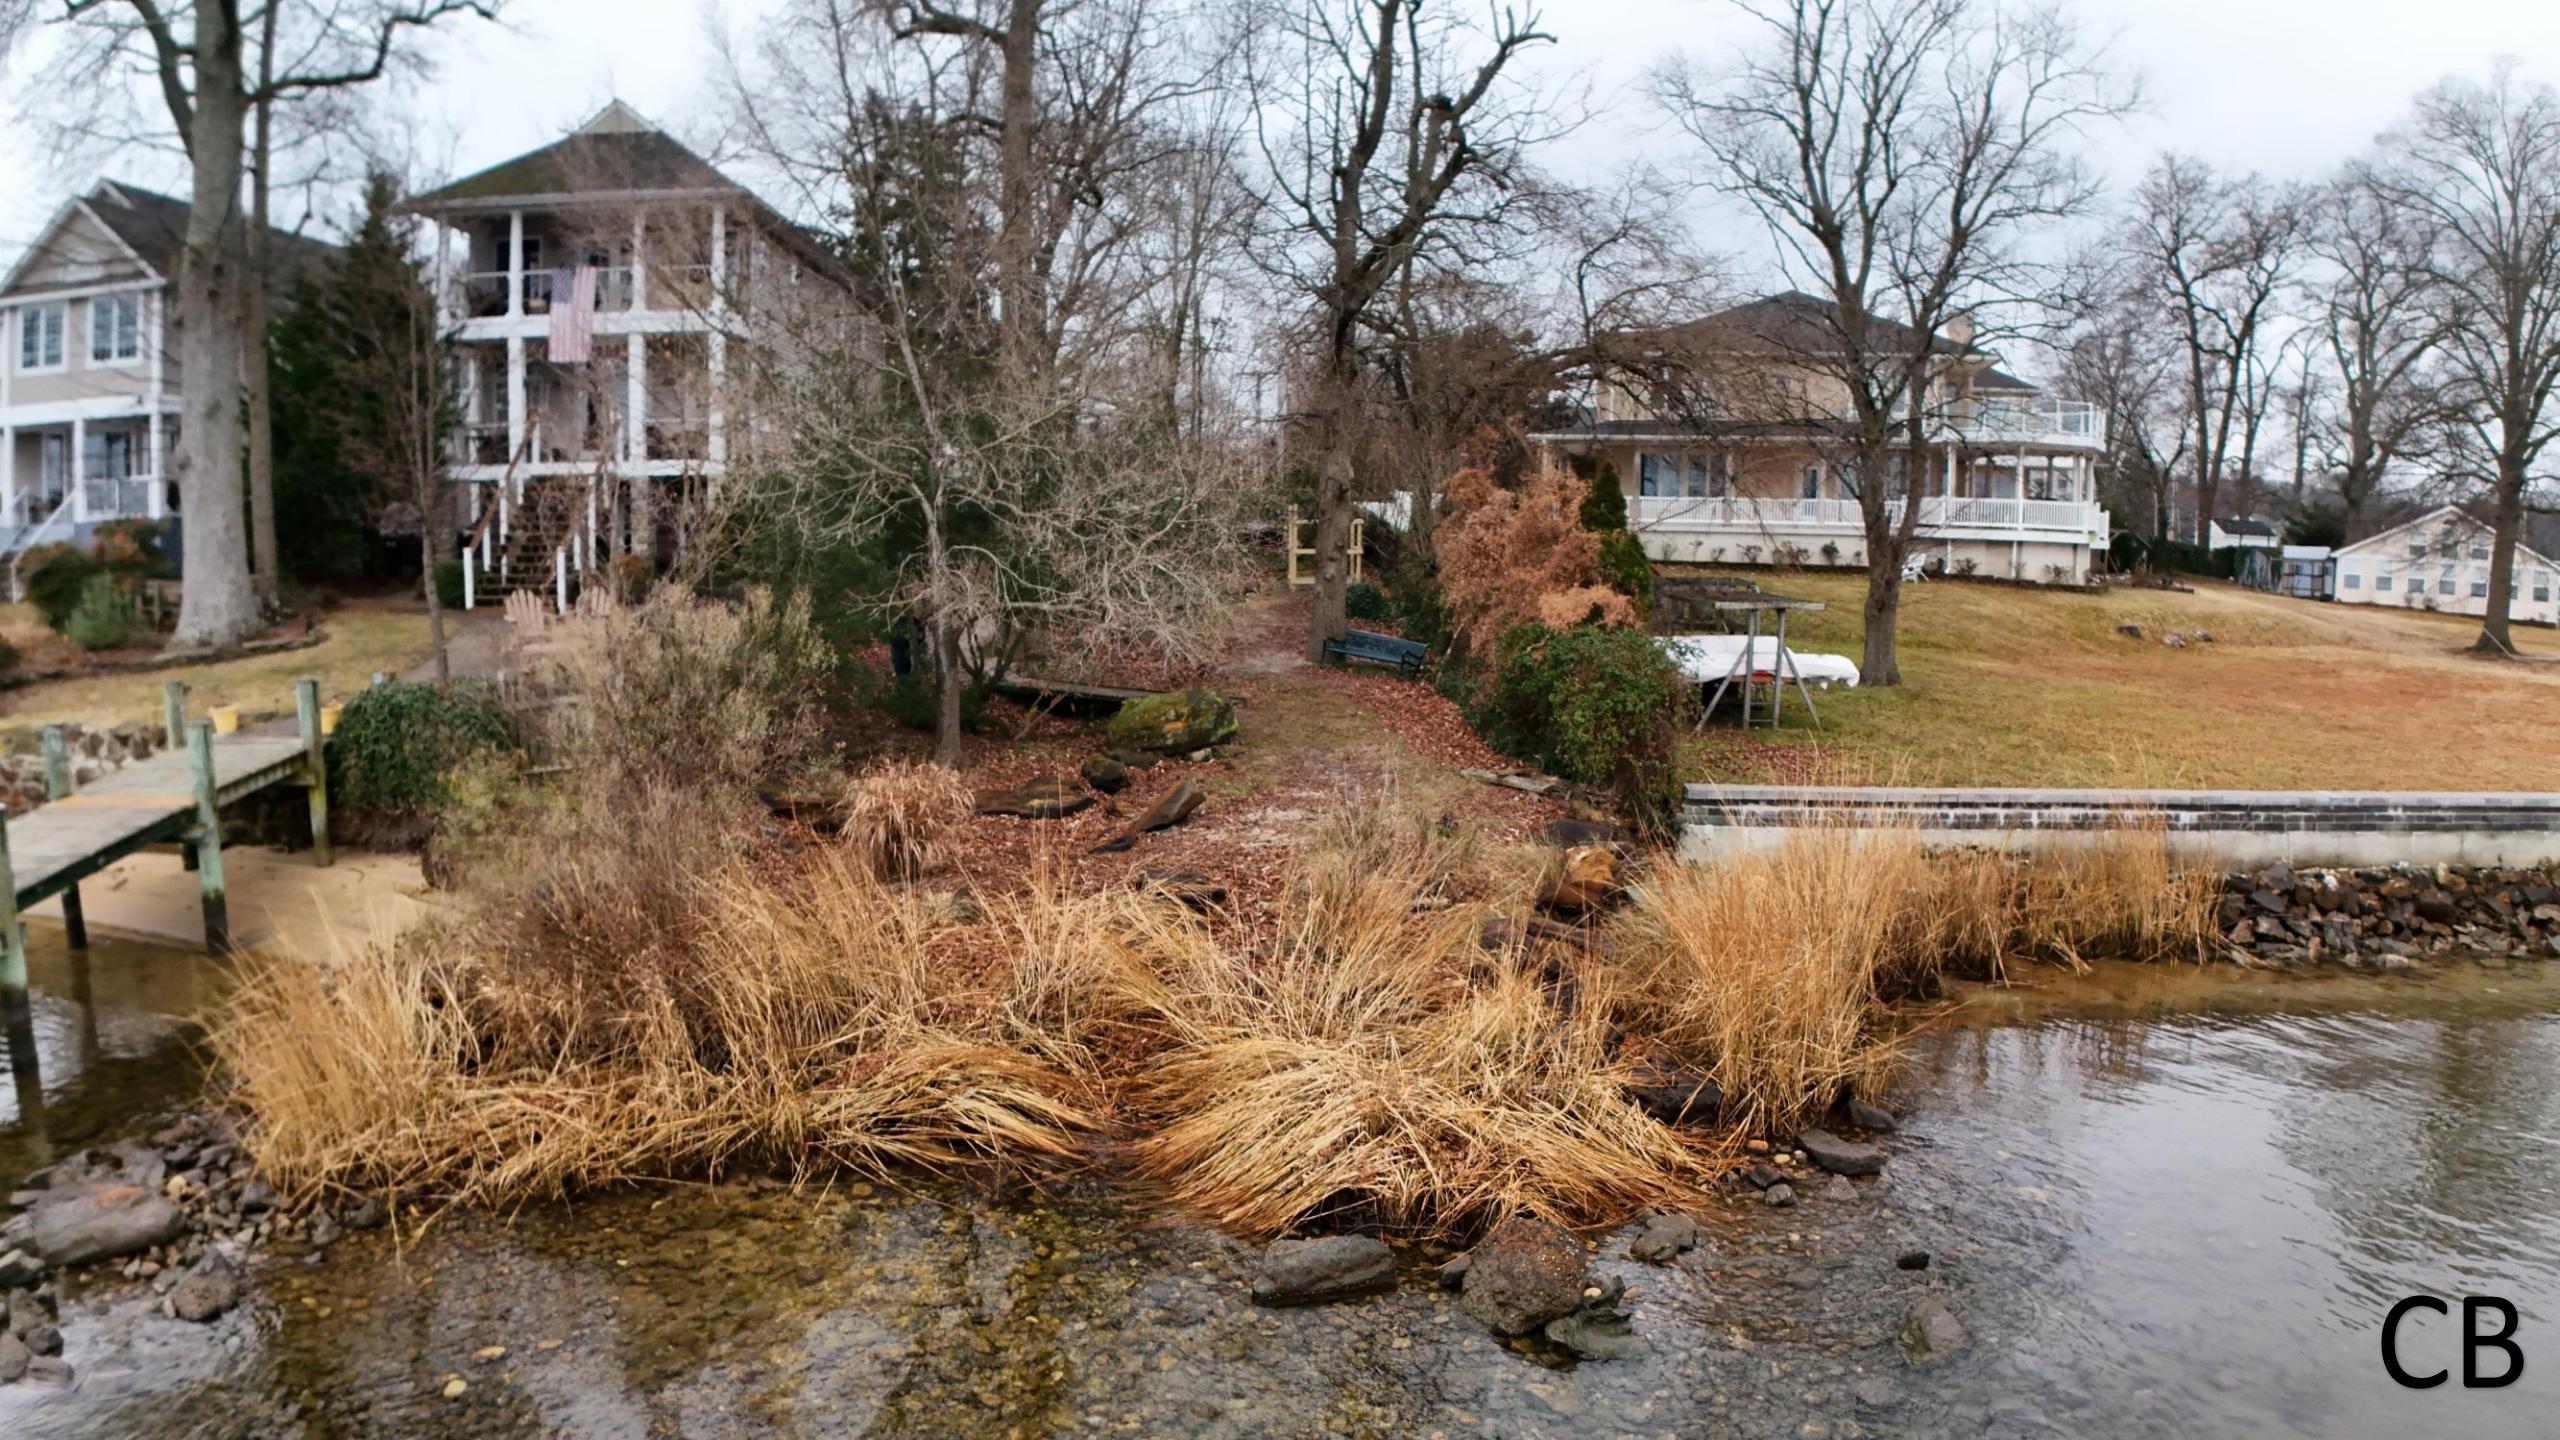
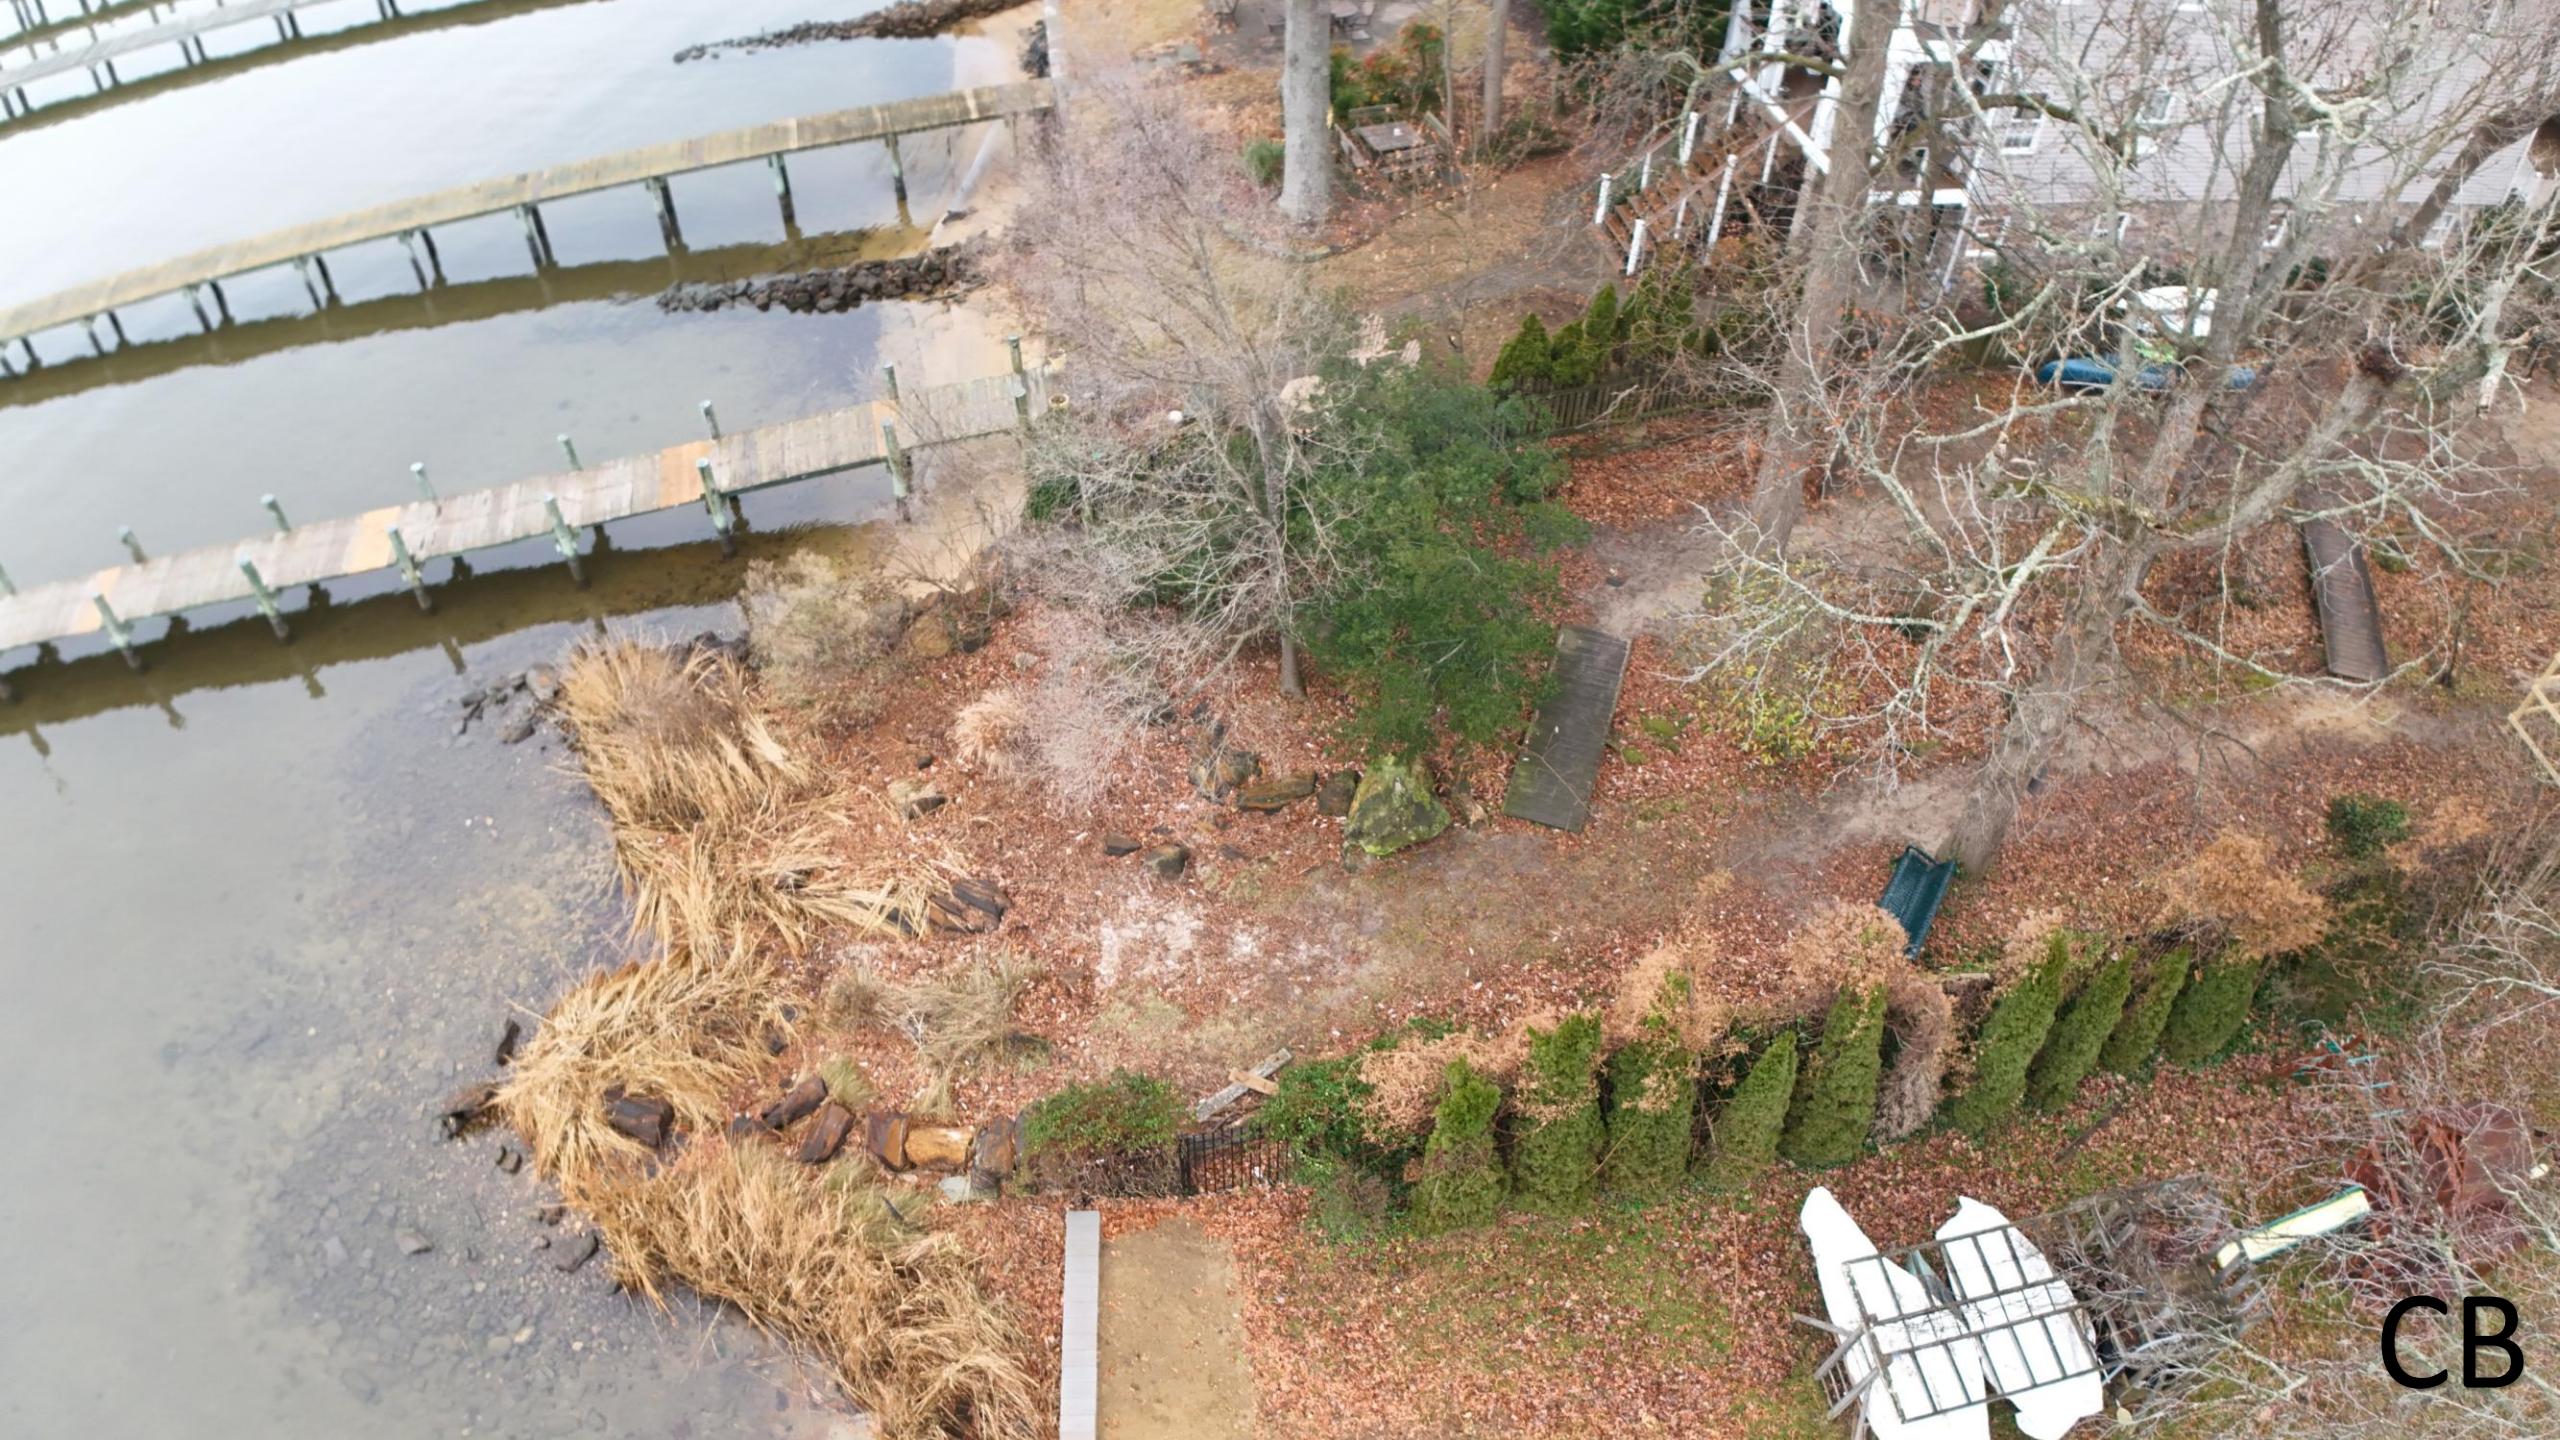
- CB is not in the current scope of work proposed, however it is in desperate need of attention.
- Cypress received a significant overhaul in 2009 to address runoff coming from the paved areas above it. While the project was a success as it eliminated the erosion and helped to clean the water before it reached the bay, it is not a functional beach today.

- There is no sand or beachfront
  - There are large rocks and tall grasses throughout the area where a beach used to be.
  - The first 10-15 feet from the waterline outward (under water) has many small and medium sized rocks you would not want to walk on.

- There are several dead or dying trees that should be removed.
- Exposed tree roots on the main path through the property are a trip hazard.
- Recommend the Board look for ways to mitigate some issues in 2026 at low or no cost through volunteers. For example, trimming branches, cutting back water grasses, removing non-functional debris, relocated rocks, etc.

- Suggest a more comprehensive plan for 2027
